Project Reference: 256015

**Abermad Mansion
Llanfarian
Aberystwyth
SY23 4ES**

Structural survey of two chimney stacks

Aber Heating Engineers Ltd

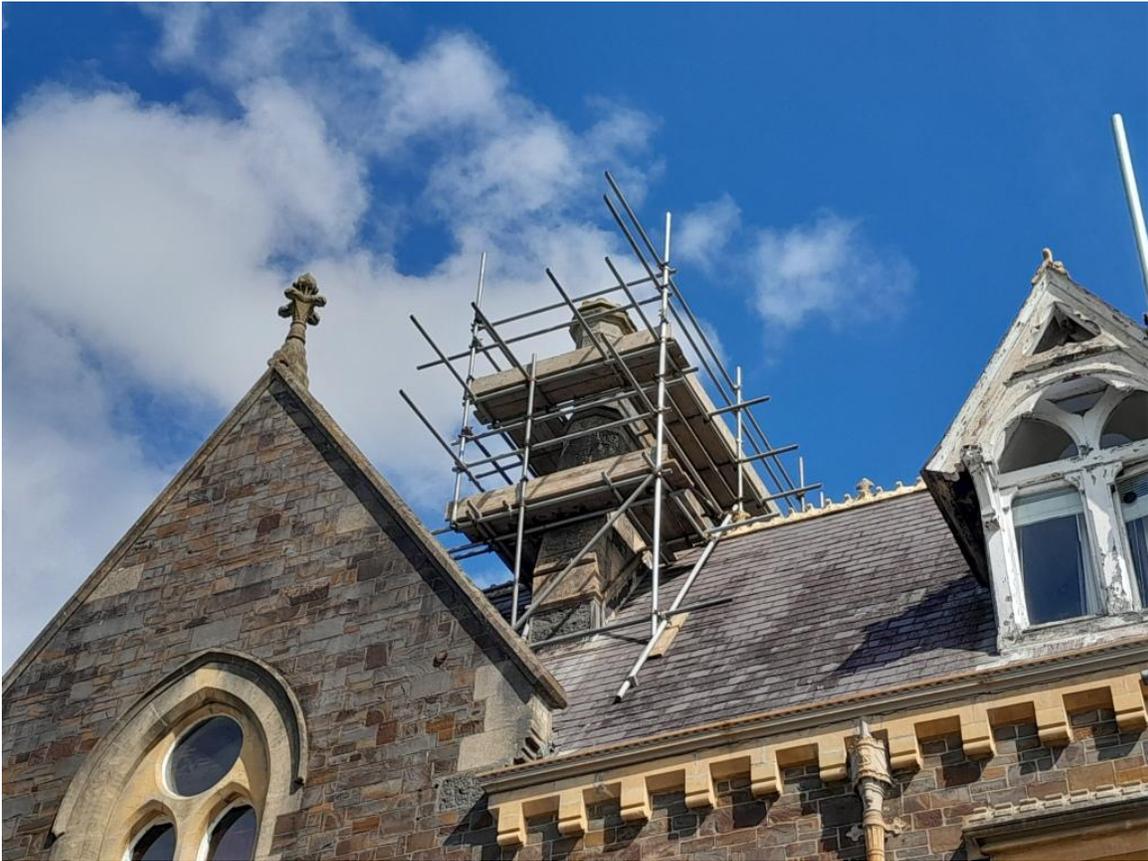
Photograph 1. Chimney stack at southwest end of building

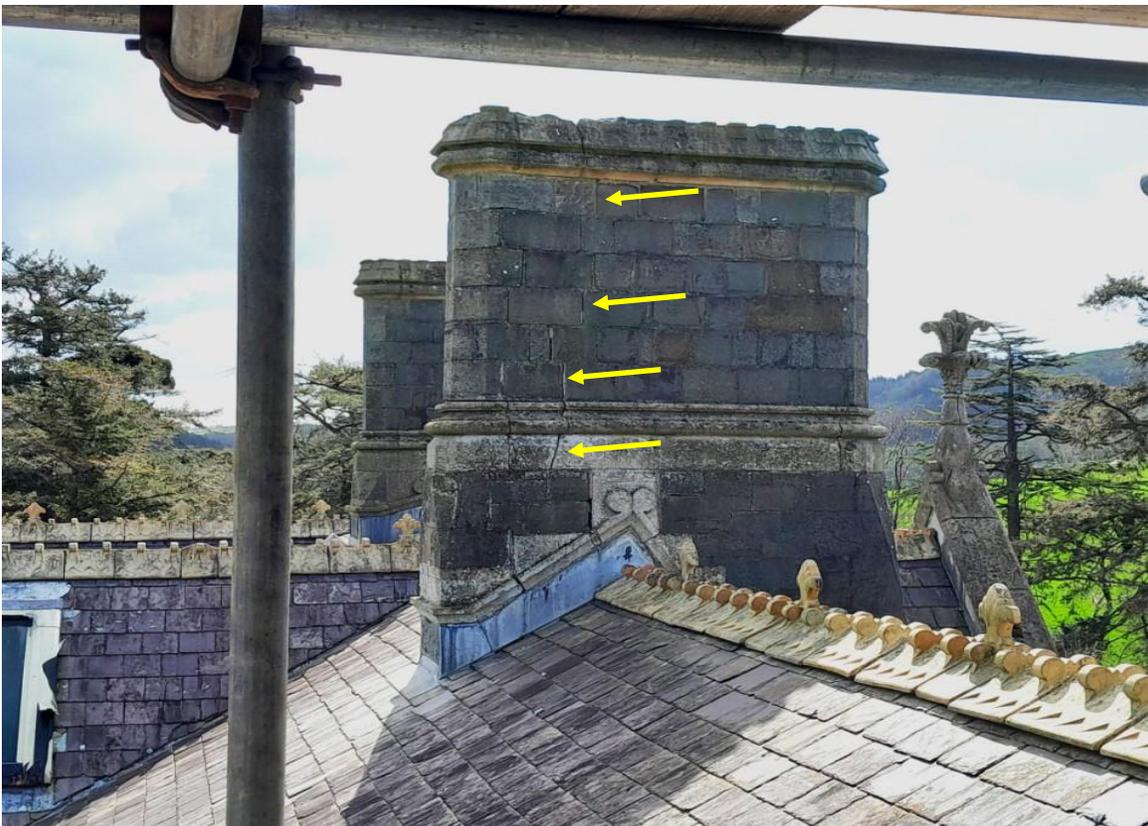
Both stacks display stepped vertical cracking extending from the sandstone collar, and the cracks are widest just above and below the collar. Some of the mortar joints have become denuded, and the sandstone on the westernmost stack has suffered from extensive erosion. There is a ferrous metal ring installed on top of the sandstone collar. Denudation of the mortar has exposed part of the metal ring, which is in an advanced state of oxidation. Ferrous metals, when exposed to water and air, will rapidly oxidize and, in so doing, can expand by as much as seven times. The rings may be of cast iron rather than steel, as this would have been easier to fabricate locally at the time of construction. The stepped cracking as described above can be directly attributed to the expansion of the metal, which is lifting the stones on the top of the stack. As moisture has ingressed the mortar joints, the oxidation process will inevitably continue, and without remedial action, the stonework will eventually be pushed apart to the point where collapse may occur.

Photograph 2. Central chimney stack showing vertical cracking

Any attempts at arresting the oxidation of the metal and repairing the mortar joints will only be a temporary solution, with a high probability that, within five years or so, further repairs will again be necessary. We strongly recommend, therefore, that the chimney stacks be taken down to the level of the sandstone collar, which will enable the metal rings to be removed completely before rebuilding the stack.

The stones that are to be taken down will need to be numbered so that the rebuilt stack will be identical to the original. The metal ring can be replaced with a binder, which can be a bed of lime mortar with stainless steel helical ties set within the mortar.

The stonework around and below the sandstone collar will need to be re-pointed, and for this, lime mortar should be used. Some of the joints will require deep pointing (>25 mm), which will necessitate applying the mortar in two stages. Lime mortar cures by a reaction between the lime (calcium hydroxide, Ca(OH)_2) and carbon, usually in the form of atmospheric carbon dioxide (CO_2), which has a diffusion distance of about 25 mm through the mortar. A pozzolan additive can be introduced into the mortar, which will provide additional carbon, thereby enhancing the curing process. Pozzolans are high-carbon compounds, such as volcanic ash, or, in the absence of any local supplies, fly ash from incinerators is typically used.

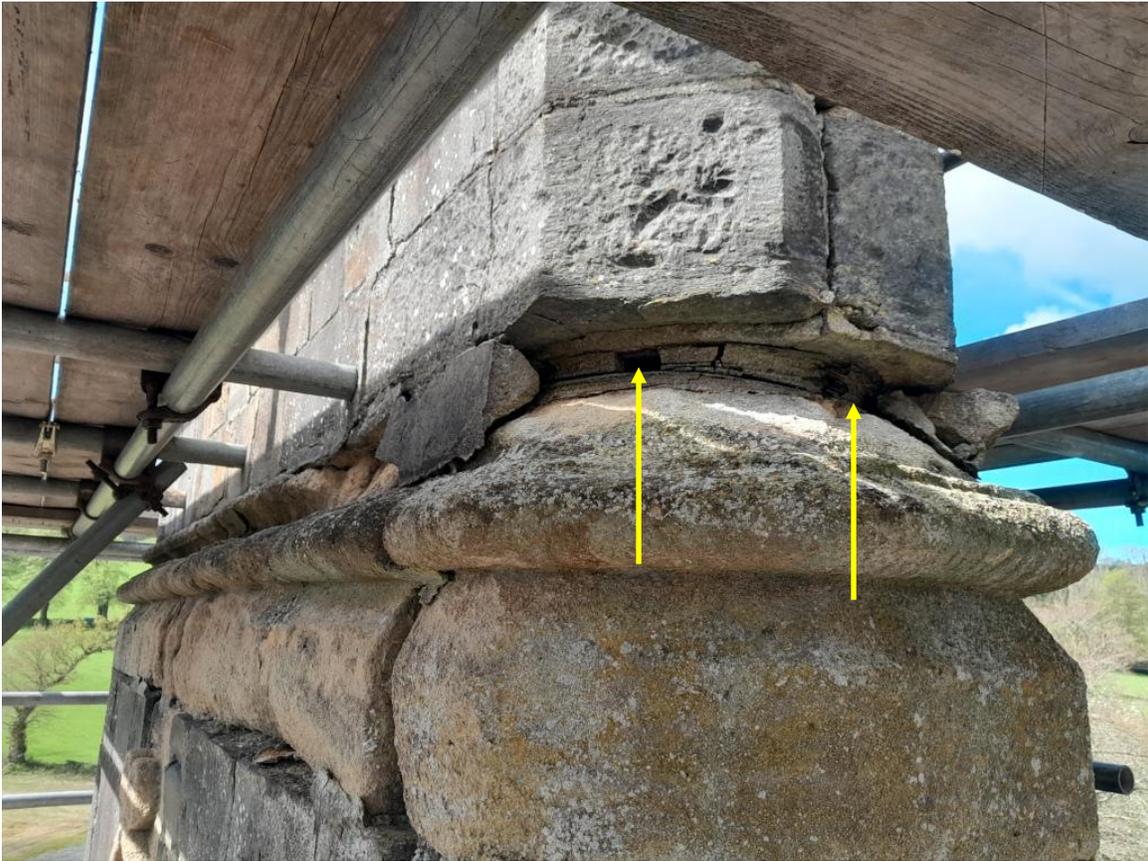
Photograph 3. West chimney stack showing damaged stonework and position of corroding metal above the sandstone collar (arrowed)

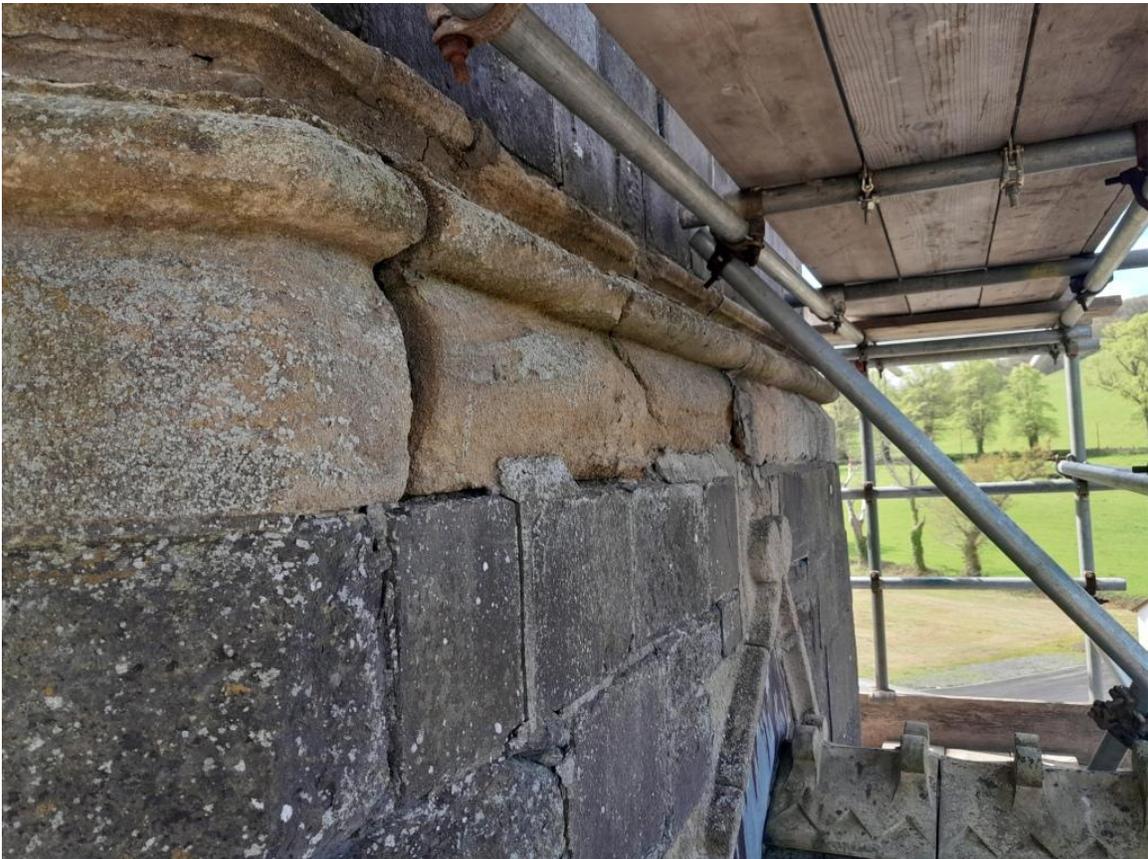
Photograph 4. Cracking in stonework, west chimney
