Bat Report Title:	Abermad Mansion
Version Number:	1
Issue Date:	02/09/24
Site Address:	Abermad Aberystwyth
Lifespan of report	2 years
ECOLOGIST	DAVE ROGERSON, S090164-1

The building under investigation is a stone block mansion. The buildings are found outside the hamlet of Abermad, SN 60029 76088.

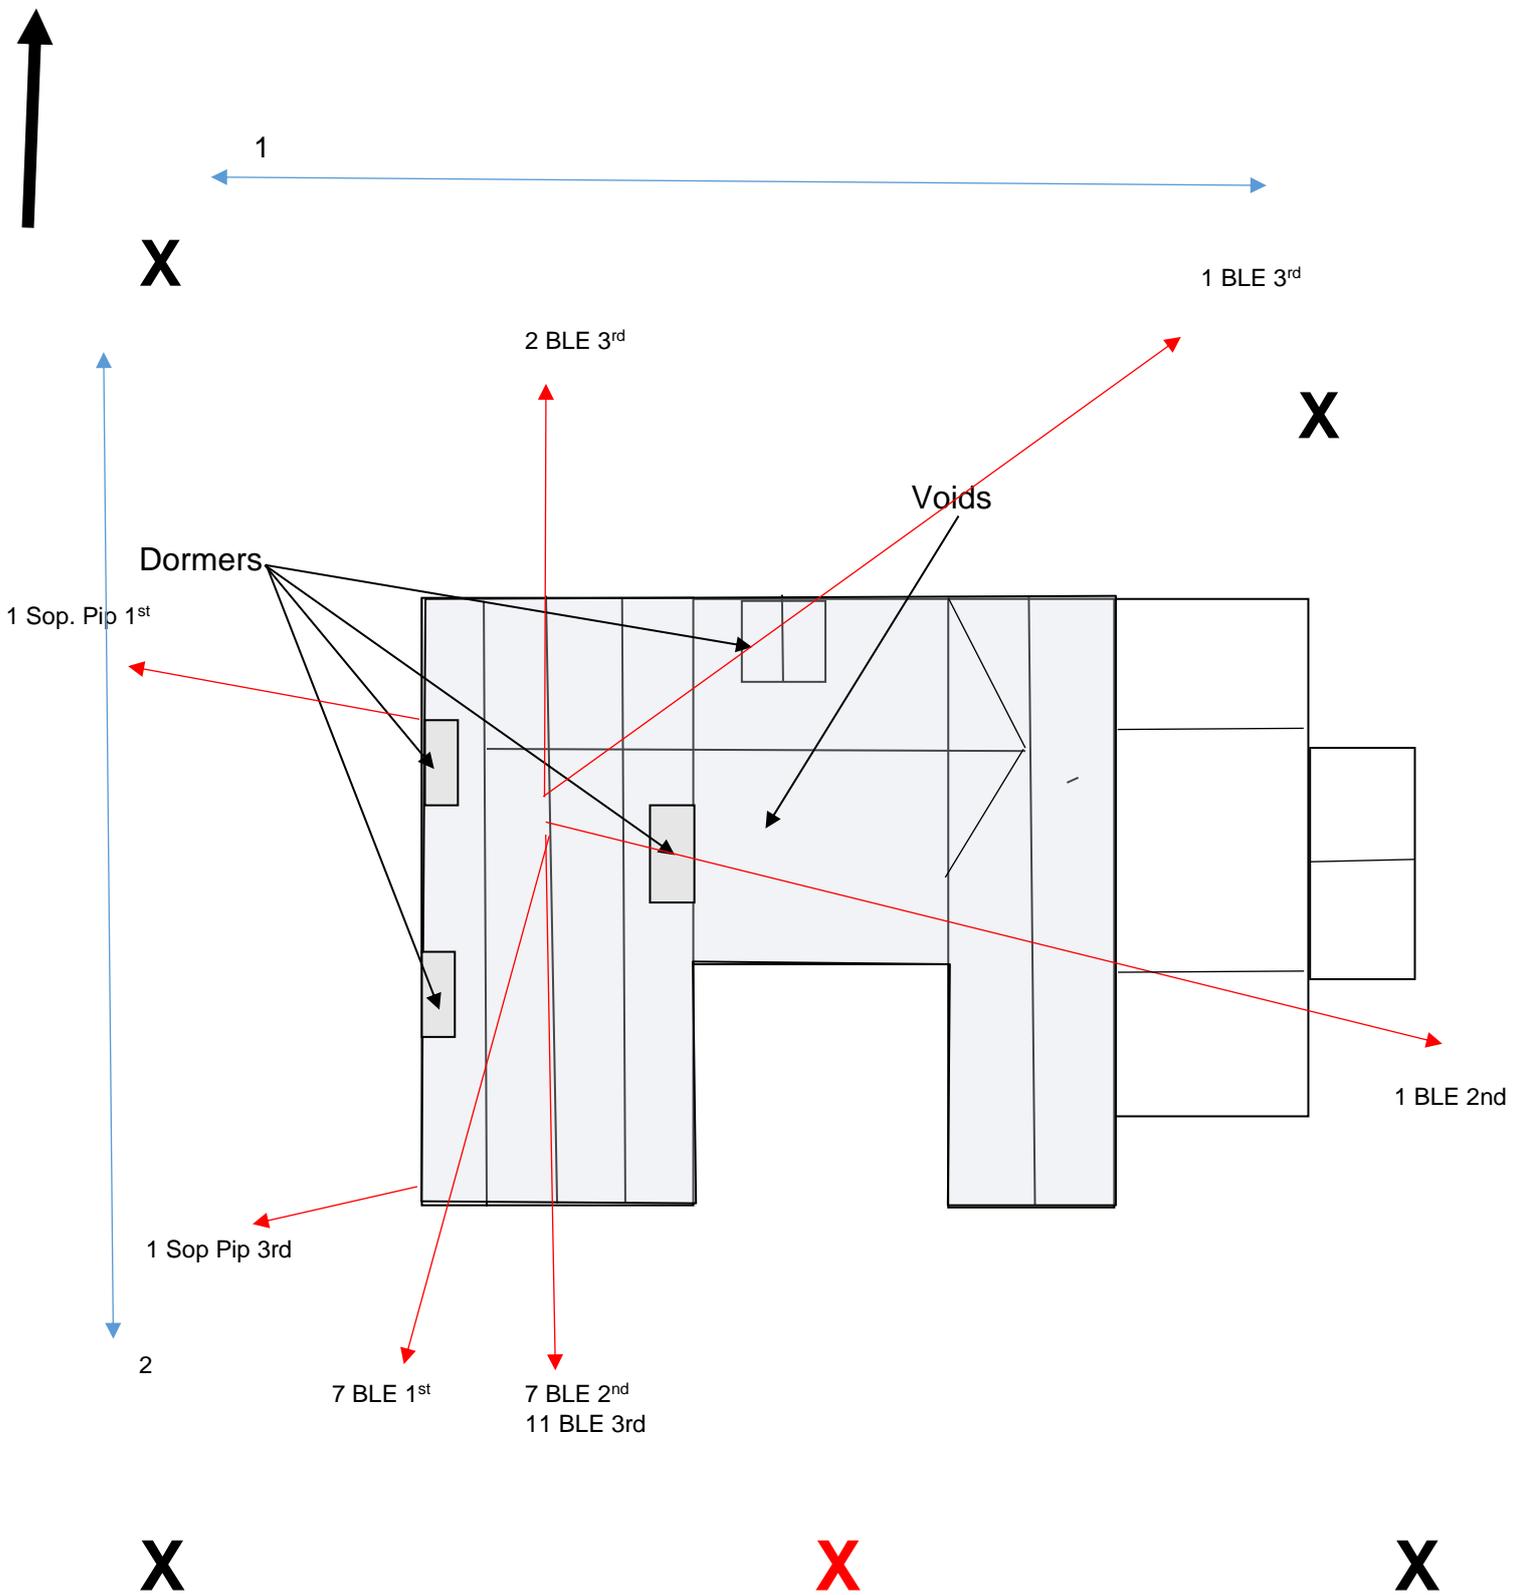
Fig.3: Plan of building (not to scale). The X's show the location of the surveyors. The blue lines show the direction of travel of passing bats, the red arrows are the bats which emerged.

- There are four roof voids within the house, see Fig. 3. The voids are separate but are connected by crawl ways. All voids are very large, approximately 2.5-3m high. The woodwork is well sawn and jointed timbers. All flat surfaces were checked for bat sign. Bat sign was found throughout all the voids. The droppings were well spread out, with no obvious clusters. There appeared to be two types of dropping, possibly Pipistrelle species and Brown Long Eared. Two of the voids have skylights which create large amounts of light pollution.

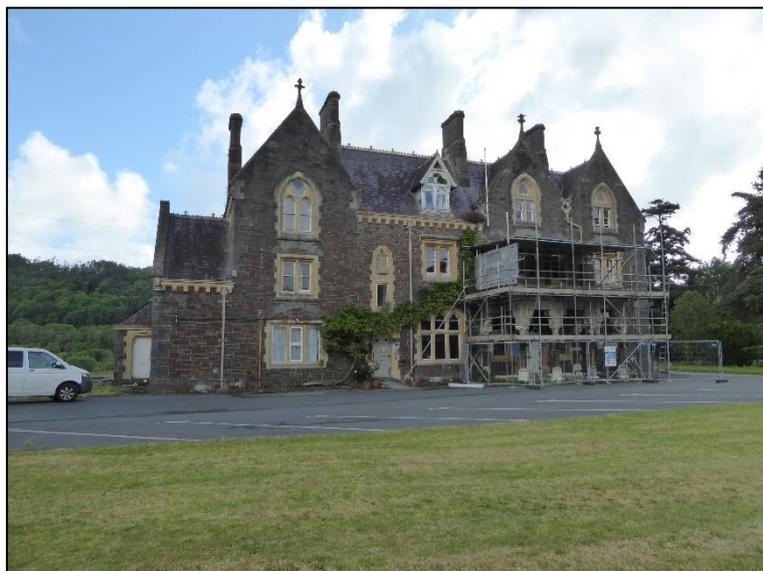
Fig. 4: Front elevation

- The walls of this historic building are bare stone walls, with Bedford stone and brick embellishments. The pointing of these wall is in good order, with no obvious crevices. All walls were checked for bat sign, using high powered binoculars.

- The eaves appear to be sealed.
- All windows, doors, sills and lintels were checked for bat sign. None was found
- The roofs are slate and appear to be in good condition.

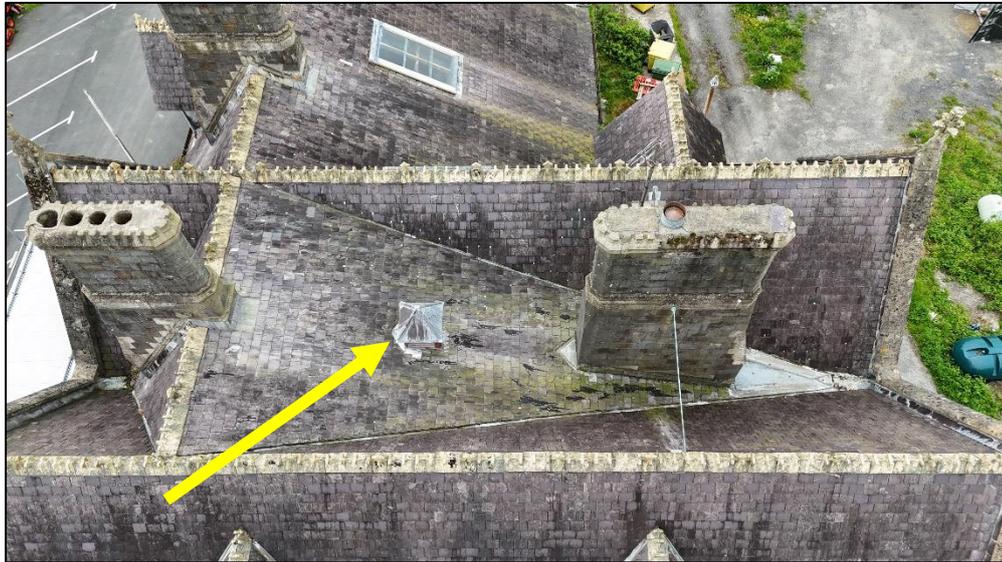
The building was found to have a high potential for bats, and one Soprano Pipistrelle bat and fourteen Brown Long Eared were observed exiting the roof area on the eastern side of the mansion. The precise location of the exit point could not be seen. It is believed that a wooden vent is being used by the bats.

Fig.6: Image of the vent from a drone

A method statement **MUST** be written, which will detail the necessary strategies to mitigate for the impacts on the roosting space, and the impact felt by the local Soprano pipistrelle and Brown Long Eared bat populations.

- Erection of two bat box to mitigate for any disturbance (noise/ vibration)
- Contractors will be informed to carry out works in a methodical manner as there is a low significant roost in the roof. Minimising noise and vibration, especially during the sensitive periods for bats, ie between May and the end of August/ Sept..

- No lighting will be place near any known or suspected bat access points. If any new external lighting is provided, low level, low wattage lighting (e.g. bollard lights and lights below 1m) will be used. All lights will be angled or screened to minimise light spill up onto the soffits/leaves, and onto the surrounding vegetation. If required, illumination of any access paths to the property will be low level, low wattage lighting, and will not be left on all night (e.g. triggered by PIR sensors on short illumination timers).

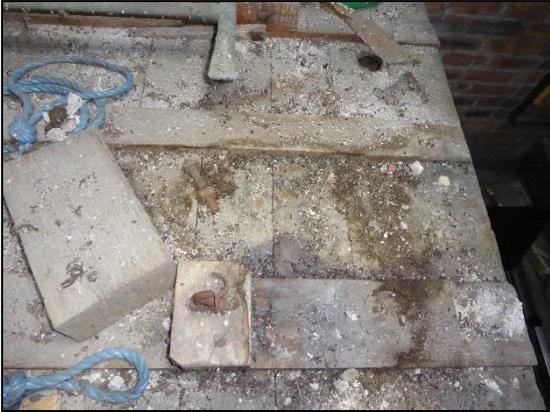
Fig.7: Scattering of droppings

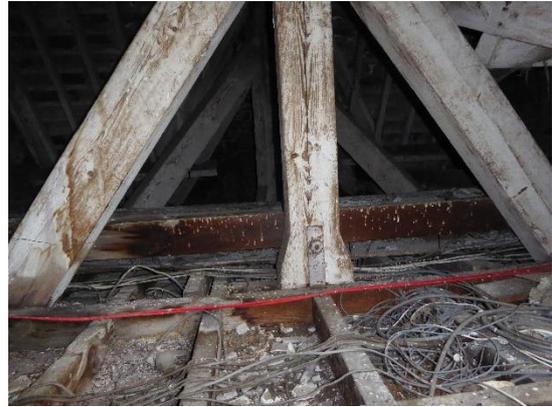
Fig.8: Void

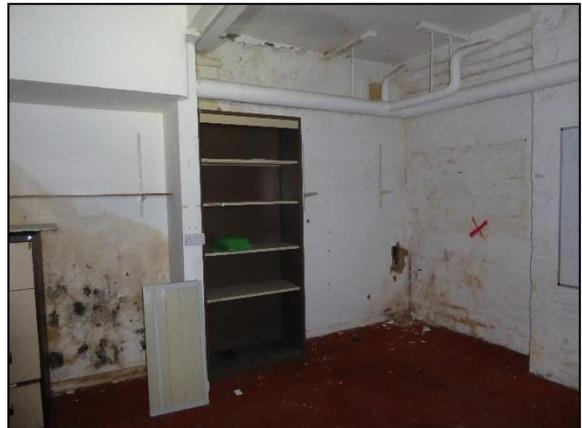
- There is a cellar under the house. The cellar is large and extensive. The cellar has historically been converted into wash areas and offices.
- Bird nests were found within the voids.

Fig.10: Converted cellar
